Top hammer tools failure analysis guide

Top hammer tools

failure analysis guide

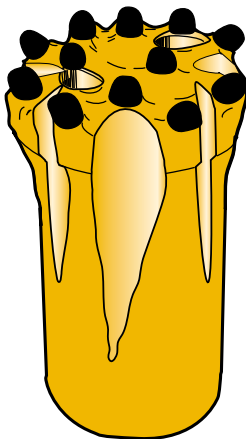
Failure mode	Probable cause	Recommended action
<p>A:1 BODY WASH</p>

<p>Excessive flushing volume</p> <p>Drilling with excessive flushing volume can in some rock cause sand-blasting of the steel and too big protrusion and breakage of the buttons</p>	<p>Reduce flushing volume</p> <p>Shorten grinding intervals</p>
<p>A:2 SPLIT SKIRT</p>

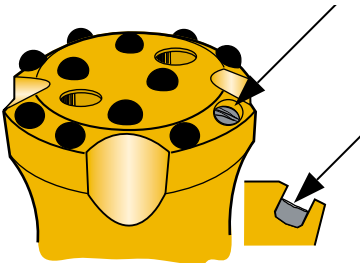
<p><i>Error code S9</i></p>	<p>Drilling in non-abrasive rock creates micro-fractures in the carbide sometimes looking like snake skin</p> <p>The rock leaves a shiny surface on the buttons and a fatigue in the surface of the cemented carbide, leading to button failure</p>	<p>Earlier regrinding even if there are no or small wear flats</p> <p>Use a softer carbide grade</p>
<p>A:8 BUTTONS SHEARED-OFF UNDER BODY LEVEL</p>

<p><i>Error code S7u</i></p>	<p>Excessive button protrusion through incorrect grinding or steel wash. Protrusion greater than 3/4 of the button diameter may not provide sufficient support to resist the tensile forces that the button may encounter.</p> <p>Incorrect size correlation between button and button hole</p>	<p>Shorten grinding intervals</p> <p>Return for analysis</p>

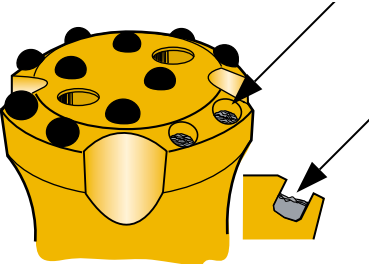
<p>A:9 BUTTONS CRUSHED INSIDE THE BIT BODY</p>

<p><i>Error code S4u</i></p>	<p>Bad collaring practices</p> <p>Anti-taper from abrasive rock</p> <p>Excessive button protrusion from incorrect grinding. Button protrusion greater than 3/4 of the button diameter will not provide sufficient support to resist the tensile forces that the buttons may encounter</p>	<p>Ensure the boom is secure. Start collaring with reduced impact, then full pressure once bit is embedded 300 mm in the rock</p> <p>Grind bit to original shape</p> <p>Ensure correct grinding procedures</p>

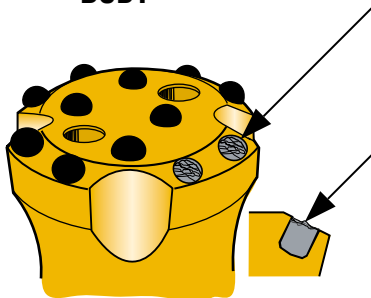
<p><i>Error code S3</i></p>	<p>Overdrilling</p> <p>Snakeskin. Overdrilling in soft, non-abrasive rock leaves a shiny surface on the buttons</p> <p>Button carbide is too hard</p> <p>Button not in contact with virgin material on impact</p>	<p>Shorten grinding intervals. Regrind when the wear flats are max. 1/3 of the button diameter</p> <p>Regularly inspect the bits and grind to remove micro-cracks from the surface of the carbides</p> <p>Choose softer or tougher grade of carbide</p> <p>Increase rotation speed</p>
<p>A:11 BUTTONS CRUSHED DOWN TO LEVEL OF BIT BODY</p>

<p><i>Error code S4</i></p>	<p>Snakeskin. Overdrilling in soft, non-abrasive rock leaves a shiny surface on the buttons and a fatigue in the surface of the cemented carbide, looking like snakeskin</p> <p>Overdrilling</p> <p>Incorrect grade of carbide</p> <p>Incorrect grinding procedures</p>	<p>Regularly inspect the bits and regrind regularly although the buttons seem not worn, just polished, to remove micro-cracks from the surface of the carbides</p> <p>Shorten grinding intervals</p> <p>Change carbide grade. See product catalogue or bit selection guide</p> <p>Dry grinding can result in snakeskin fatigue. Employ wet grinding</p>

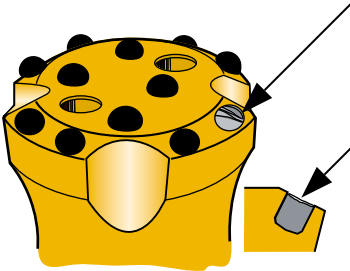
Failure mode	Probable cause	Recommended action
A:13 TOP OF BUTTON SHEARED OFF LEVEL WITH BODY

<i>Error code S7</i>	Overdrilling	Shorten grinding intervals. Regrind when the wear flats are max 1/3 of the button diameter
	Drilling into metal	Ensure correct drilling practices
	Snakeskin	Regularly inspect the bits and grind to remove micro-cracks from the surface of the cemented carbide
	Excessive button protrusion through incorrect grinding. Protrusions greater than 3/4 of the button diameter will not provide sufficient support to resist the tensile forces that the buttons may encounter	Shorten grinding intervals

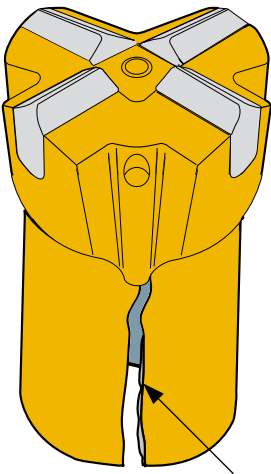
Failure mode	Probable cause	Recommended action
B:1 SPLIT SKIRT (taper bits)

<i>Error code B2</i>	Taper mismatch or worn taper	Use a taper gauge to check taper angle. Change to proper bits
	Removing a bit with a hammer or miner's wrench	Utilise a proper knock-off block when removing bit

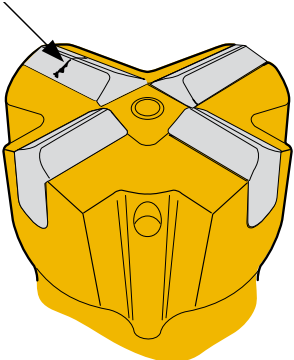
Failure mode	Probable cause	Recommended action
<p>B:2 TRANSVERSAL CRACK</p>

<p><i>Error code S1</i></p>	<p>Overheating from improper grinding</p> <p>Anti-taper from abrasive rock</p> <p>Grinding scratches due to wrong grinding wheel</p>	<p>Regrind bit to its original shape. Follow proper bit grinding procedures</p> <p>Shorten grinding intervals</p> <p>Check grinding procedures and grinding wheel</p>
<p>B:3 LONGITUDINAL CRACKS</p>

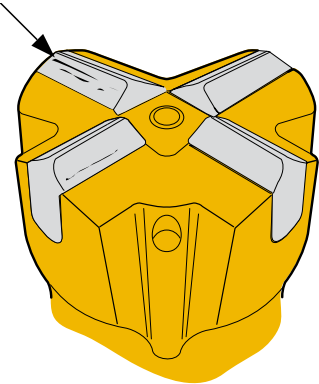
<p><i>Error code S5</i></p>	<p>Overheating from improper grinding</p> <p>Carbide grade too hard</p>	<p>Regrind bit to its original shape. Follow proper bit grinding procedures</p> <p>Select a bit with a softer, tougher grade of carbide</p>
<p>B:4 WHOLE INSERT LOST</p>

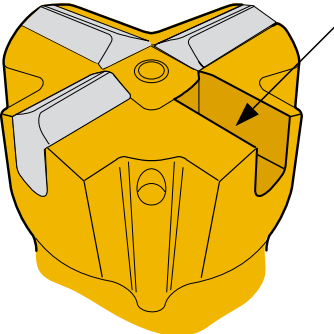
<p><i>Error code L1</i></p>	<p>Brazed joint fatigued</p> <p>Inadequate feed pressure</p> <p>Braze failure</p>	<p>Normal failure with long life</p> <p>Increase feed pressure</p> <p>Return for analysis</p>

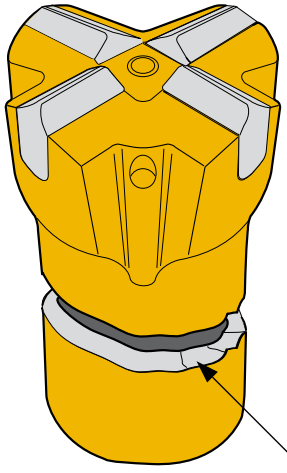
Failure mode	Probable cause	Recommended action
<p>B:5 SKIRT RING-OFF (taper bits)</p>

<p><i>Error code B1</i></p>	<p>Taper mismatch or worn taper</p> <p>Drilling with a broken taper</p> <p>Removing a bit with a hammer or miner's wrench</p> <p>Spinning</p> <p>Excessive wear of the skirt (over-drilled bit)</p>	<p>Use a taper gauge to check taper angle. Change to proper bits</p> <p>Change bit. Change to new drill steel and refurbish</p> <p>Remove bit using correct knock-off tools</p> <p>Adjust feed force</p>
<p>B:6 INSERT CORNER FRACTURED</p>

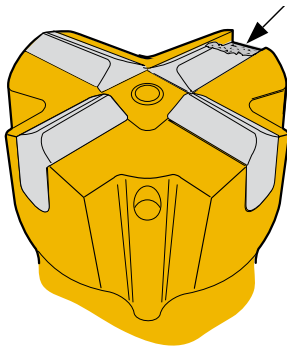
<p><i>Error code L2</i></p>	<p>Pinching by drilling into a hole that was drilled with a smaller bit</p> <p>Sharp corners or antitaper after grinding</p> <p>Removing a bit with a hammer or miner's wrench</p> <p>Drilling conditions creating snakeskin</p> <p>Bad collaring practices</p>	<p>Colour code bits by size to reduce the risk for negative gauge clearance</p> <p>Ensure proper grinding procedures</p> <p>Lower rotation and reduce hammer pressure</p> <p>Early regrinding even if there are no wear flats</p> <p>Reduce percussion and feed when collaring</p>

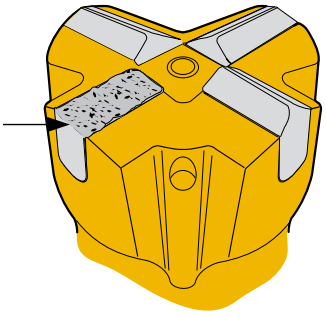
<p>B:7 INSERT SHATTERED</p>

<p><i>Error code S4</i></p>	<p>Incorrect grade of carbide</p> <p>Insufficient flushing</p> <p>Improper grinding</p>	<p>Change carbide grade, see product catalogue</p> <p>Increase flushing pressure</p> <p>Ensure proper grinding procedures</p>

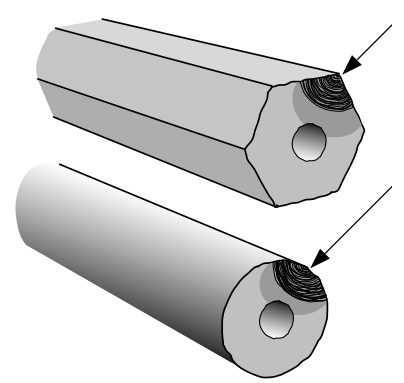
Failure mode	Probable cause	Recommended action
<p>C:1 SURFACE LAYER OF STEEL COMPROMISED BY A NICK OR DENT, FATIGUE ROSE ORIGINATING FROM THE SURFACE</p>	<p>Surface damage caused by worn out centraliser bushings</p> <p>Presence of a shiny steel surface near rose suggests martensite build up caused by rotation against steel</p>	<p>Replace centraliser</p>

<p><i>Error code Kxxu/Nxxu</i></p>	<p>No centraliser used</p> <p>Using a sledge hammer on stuck steel</p> <p>Improper care and handling</p> <p>Wandering or drifting hole</p> <p>Excessive feed</p> <p>Bending due to misalignment</p>	<p>Ensure proper maintenance of rig</p> <p>Use a rod wrench to loosen</p> <p>Store rods in a rack when retracting drill string. Do not drop rods or store on the ground</p> <p>Employ guide tools and ballistic button bits</p> <p>Monitor feed pressure and tune to rock conditions</p>
		<p>Utilise alignment instruments to monitor hole orientation once then hole has been collared</p> <p>Replace wear pads on feed</p> <p>Make sure boom is stable under drilling and rig is fixed</p> <p>Avoid hanging rods when drilling in horizontal or inclined platforms. If rods are too long, consider using a travelling centraliser</p>

<p>Poor drilling conditions. Drilling in voids, seams and/or broken conditions</p>	<p>Ajdjust drilling pressures and tune to rock conditions</p> <p>Avoid stuck in hole by adjusting drilling pressures and tune to rock conditions</p> <p>Use Retrac bits</p>
	<p>Feeder damaged when scaling in drifter tunnelling</p>	<p>Check feeder is not bent or twisted</p>

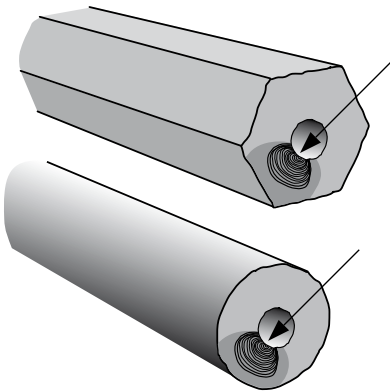
Error code Kxxi/Nxxi

Failure mode	Probable cause	Recommended action
C:2 ROD BREAKAGE CHARACTERISED BY A FATIGUE ROSE ORIGINATING FROM THE FLUSHING HOLE	Corrosion caused by corrosive flushing agents	Ensure that proper storage practices are being followed. Change components more frequently or neutralise flushing agents
	Insufficient rust treatment	Return for analysis
	Pores in flushing hole surface	Return for analysis

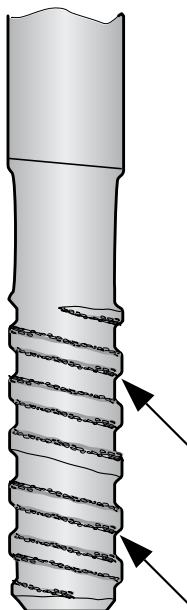
Error code A11

C:3 PITTING OR WEAR IN THE THREADS

Overheated threads due to loose connection or hole deviation. Reflected percussive energy	Tune percussion and feed pressures to conditions (in most cases reduce percussion pressure and increase feed pressure). Use a ballistic button bit to help tighten drill string. If caused by hole deviation take steps to drill straighter holes
Free hammering	Do not engage full percussion unless the bit is firmly seated against rock. Use reduced percussion when collaring on uneven surfaces
Worn threads	Replace worn components. Do not put a worn rod on a new rod. Change out all rods together
Drilling with worn bits	Regrind the bit when the wear flats are max. 1/3 of the button diameter

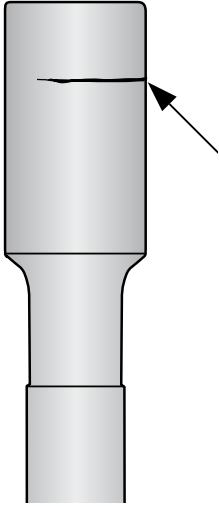
Failure mode	Probable cause	Recommended action
<p>C:6 FAILURE ACROSS FEMALE THREAD SECTION</p>

<p><i>Error code B1</i></p>	<p>Hole deviation or feed misalignment</p> <p>Inadequate feed pressure. Starting point pittings on thread</p> <p>High torque from drilling with worn bits</p> <p>Mismatching threads</p> <p>Nick or dent in steel surface</p>	<p>Employ guide tools and ballistic button bits</p> <p>Monitor feed pressure and tune to conditions</p> <p>Regrind the bit when the wear flats are 1/3 of the button diameter</p> <p>Ensure all components are Sandvik manufactured. Do not "mix and match"</p> <p>Avoid hammering on connection. Use a wrench to loosen joints. Employ proper care and handling procedures</p>

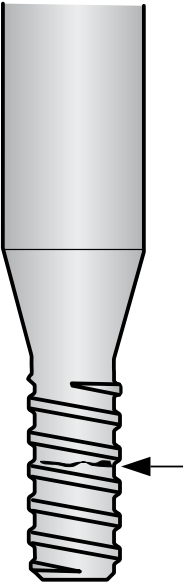
Error code Kxx

Failure mode	Probable cause	Recommended action
D:2 FAILURE ACROSS MALE THREAD SECTION

Inadequate feed pressure	Monitor feed pressure and tune to conditions
	Breakage starting from pitting on thread	See D:3 below
	High torque caused by drilling with a worn bit	Regrind the bit when the wear flats are 1/3 of the button diameter
	Mismatching threads	Ensure all components are Sandvik manufactured. Do not "mix and match"
	Nick or dent in steel surface	Avoid hammering on bit. Employ proper care and handling
	Worn threads	Replace worn components

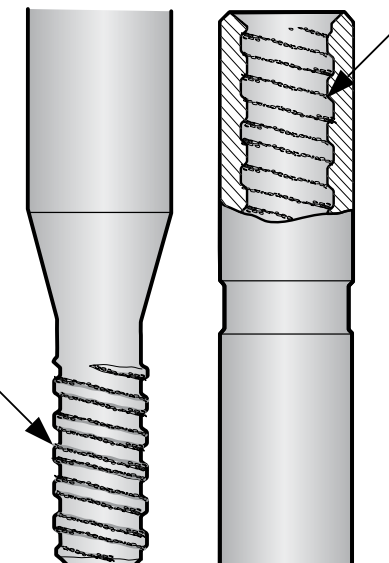
Error code A11

D:3 PITTING OR WEAR IN THE THREADS

Reflected percussive energy	Adjust feed and percussion pressures to the rock conditions
	Free hammering	Do not engage full percussion unless the bit is firmly seated against rock. Use reduced percussion when collaring on uneven surfaces
	Worn threads	Replace worn components
	Drilling with worn bits	Regrind the bit when the wear flats are max. 1/3 of the button diameter

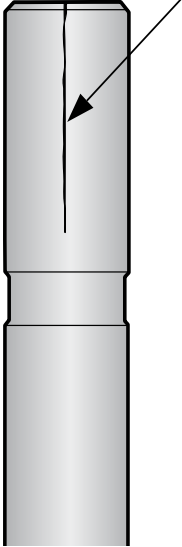
Failure mode	Probable cause	Recommended action
<p>D:4 LONGITUDINAL CRACK IN FEMALE CONNECTION</p>

<p><i>Error code B2</i></p>	<p>Worn out threads</p> <p>Misalignment of rods. Steel hitting coupling shoulder</p> <p>Hammering with open threads gives wedging effect which can split the coupling</p>	<p>Replace components in time</p> <p>Service affected equipment</p> <p>Always make sure that connection is tight before hammering</p> <p>Avoid excessive back hammering</p>

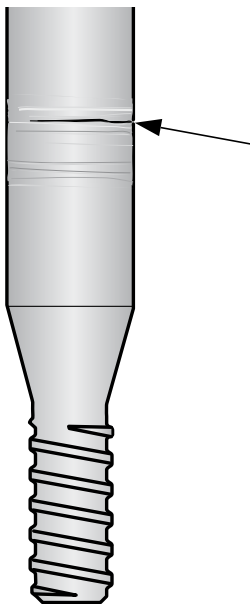
<p>D:5 BREAK IN TUBE BODY</p>

<p><i>Error code Kxx/Nxx/B1</i></p>	<p>Surface damage caused by worn out centralisers</p> <p>Nick or dent in steel surface</p>	<p>Replace centralisers</p> <p>Avoid hammering on the tube. Employ proper care and handling</p>
--	--	---

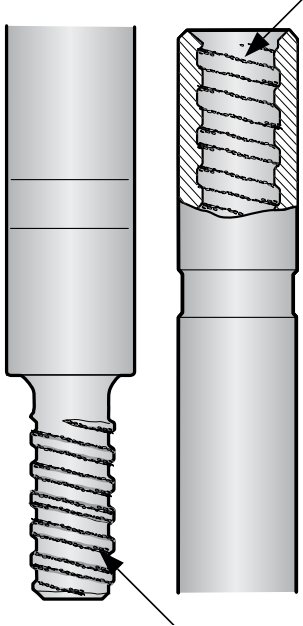
Failure mode	Probable cause	Recommended action
E:1 PITTING OR WEAR ON THREADS

<p><i>Error code A11</i></p>	<p>Inadequate feed pressure and/or high percussion</p> <p>Cuttings in thread</p> <p>Corrosion caused by corrosive flushing agents</p>	<p>Adjust machine settings</p> <p>Keep flushing on when breaking pipe</p> <p>Change out components more frequently or neutralise flushing agent</p>

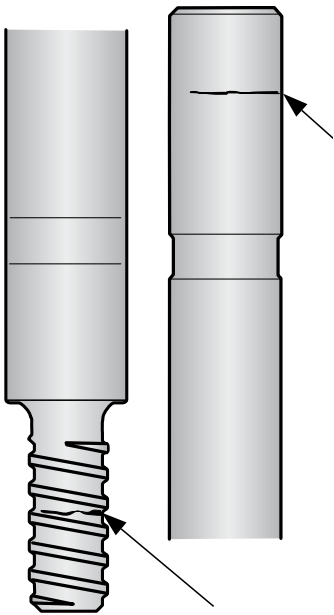
E:2 FAILURE IN MALE OR FEMALE THREAD SECTION

<p><i>Error code Kxx/Nxx</i></p>	<p>Misalignment of feed</p> <p>Hole deviation</p> <p>Hit on thread</p> <p>Corrosion caused by corrosive flushing agents</p>	<p>Make sure boom is aligned. Ensure good collaring practices</p> <p>Employ Retrac bits with ballistic buttons</p> <p>Ensure good rod handling practices</p> <p>Change components more frequently or neutralise flushing agent</p>
---	---	--

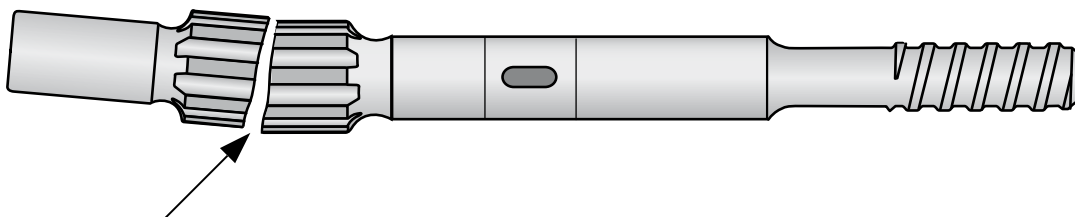
Error code Nxx

F:2 FAILURE ACROSS SPLINES	Poor or no lubrication	Ensure functioning lubrication
	Wrong or contaminated shank lubrication oil	Change to correct oil
	Stuck rod in broken rock and/or excessive back hammering	Use Retrac bits and activate anti-jammig when drilling
	Worn out chuck coupling	Replace worn components
	High rotational torque	Adjust drilling pressures
	Overdrilling bits	Regrinding should be done when the wear flats are max. 1/3 of the button diameter
	Inadequate feed pressure	Monitor coupling temperatures and adjust feed pressures according to recommendations

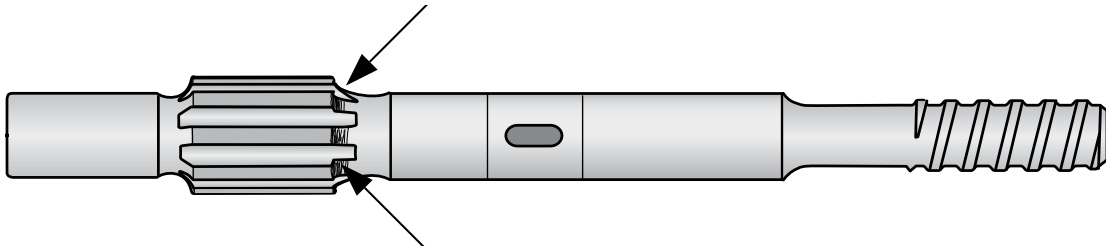
Error code C3

Failure mode	Probable cause	Recommended action
F:3 WEAR ON BOTTOM OF SPLINE SHOULDER (common in bench drilling)	Excessive rotation when retracting string	Adjust rotation speed
	Stuck rod in broken rock	Use Retrac bits and activate anti-jamming when drilling. Use a rock drill with power extractor

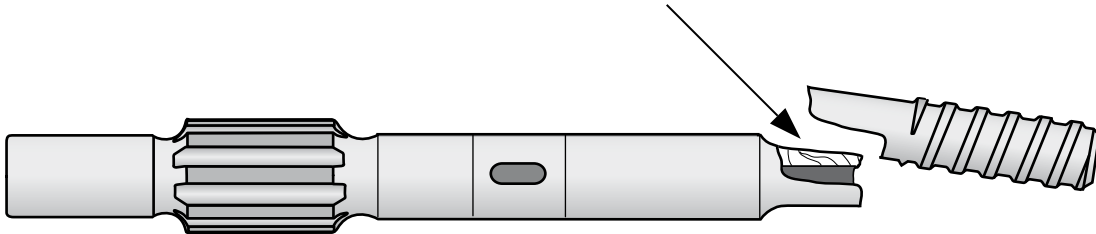
Error code Kxx/Nxx

F:4 FAILURE AT FRONT HEAD	Misaligned boom	Ensure boom is aligned when drilling
	Misalignment from worn front bushing	Replace worn components
	Excessive feed	Reduce feed pressure, tune to rock conditions

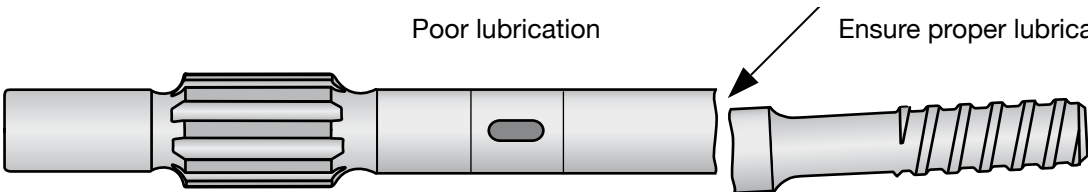
F:6 FAILURE AT FRONT BUSHING

<p>Error code Kxx</p>	Misalignment from worn front bushing	Replace worn components
	Poor lubrication	Ensure proper lubrication

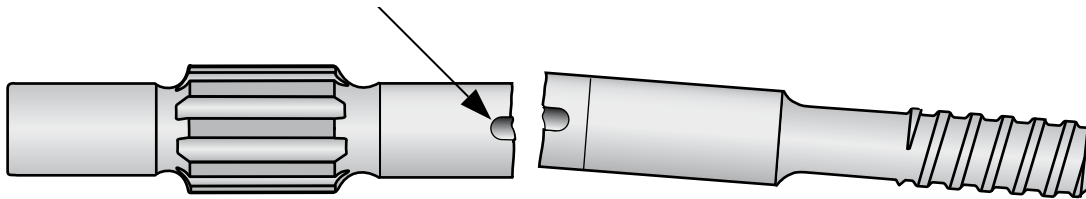
Error code Kxx

Failure mode	Probable cause	Recommended action
F:7 CORROSION	Corrosion from corrosive flushing agent	Replace broken/damaged components. Change or neutralize flushing agent
	Dirty flushing water	Clean water of solids. Use large water basins or install filters
	Fatigue	Replace more frequent

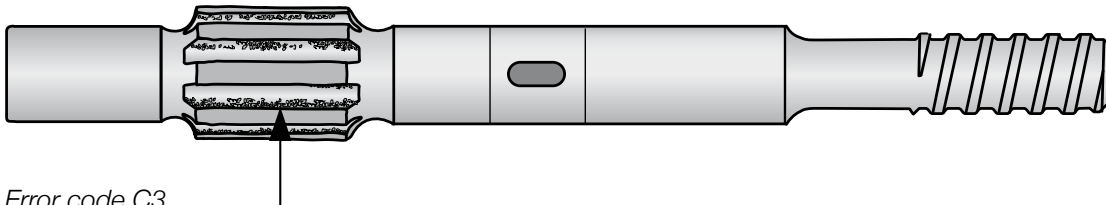
Failure mode	Probable cause	Recommended action
F:9 PITTING AND GALLING ON SPLINES	Poor or missing lubrication	Make sure that rock drill is receiving sufficient lubrication
	Excessive rotation in soft or broken ground	Adjust drilling pressures
	Incorrect shank lubrication oil	Change to recommended oil
	Hydraulic oil is too hot	Equip rig with a cooling unit
	Stuck rod in broken rock and/or excessive back hammering	Use Retrac bits and activate anti-jamming when drilling. Use a rock drill with power extractor

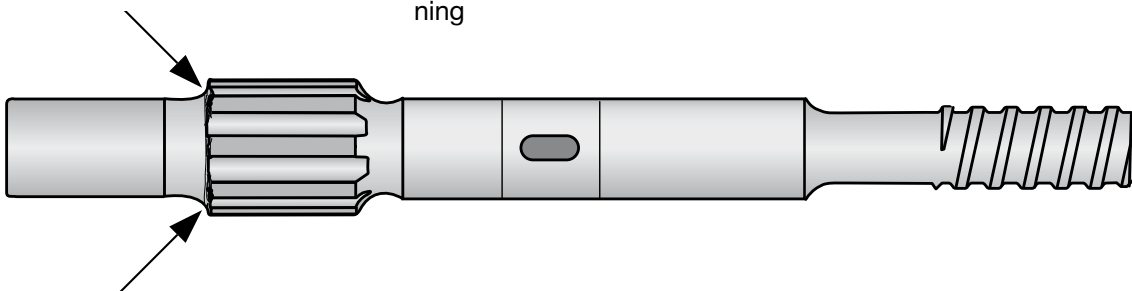
F:10 EXCESSIVE WEAR ON TOP OF SPLINE SHOULDER	Inadequate feed pressure	Adjust feed pressure according to recommendations
	Worn-out rotation bushing	Change bushing
	Damping piston is not functioning	Repair damping piston

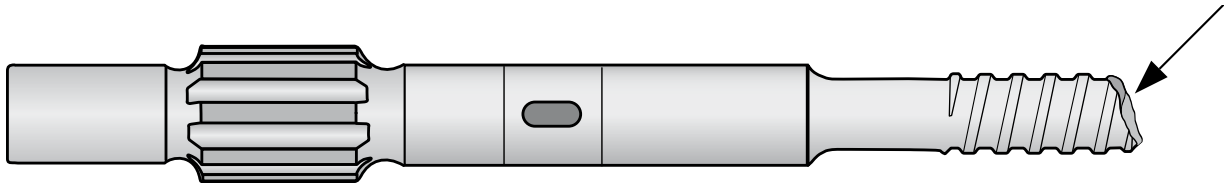
Error code B4

Failure mode	Probable cause	Recommended action
F:11 CHIPPED THREAD END	Adapter dropped into coupling Machine cradle is too loose Misalignment of boom	Inspect feed for misalignment. Secure good alignment
	Adapter not properly coupled to drill steel.	Replace worn-out couplings. Use new couplings with new shank adapters
	Broken drill rod	Replace rod
	Drill steel end not square	Check alignment or hole deviation
	Corrosion	Replace components

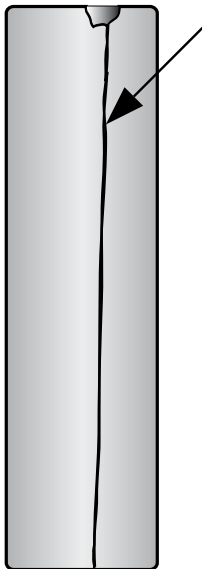
Failure mode	Probable cause	Recommended action
G:2 LONGITUDINAL CRACK

<p>Error code B2</p>	<p>Drilling with loose thread joints</p> <p>Back rotation with percussion</p> <p>Nick or dent in steel surface</p> <p>Worn-out sleeve</p> <p>Hole deviation</p>	<p>Increase the feed force. Make sure that the joints are tightened before percussion. Avoid excessive back hammering</p> <p>Do not back rotate with percussion</p> <p>Avoid hammering on connection. Rotate loose or use a wrench to loosen joints. Employ proper care and handling</p> <p>Change sleeve</p> <p>Take action to drill straighter holes, eg. use a retrac bit, guide rod etc</p>

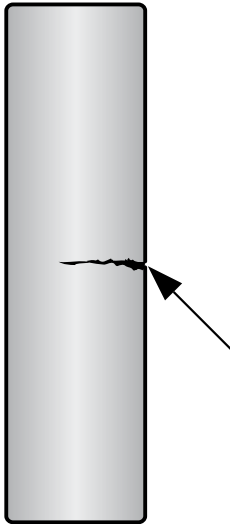
G:3 TRANSVERSAL CRACK

<p>Error code B1</p>	<p>Nick or dent in steel surface</p> <p>Worn-out sleeve</p> <p>Hole deviation or feed misalignment</p> <p>Inadequate feed pressure</p> <p>Heavy rotational loads from drilling with worn bits</p> <p>Mismatching threads</p>	<p>Avoid hammering on connection. Rotate loose or use a wrench to loosen joints. Employ proper care and handling</p> <p>Change sleeve</p> <p>Employ guide tools and ballistic button bits</p> <p>Monitor feed force and tune to conditions</p> <p>Regrind the bit when the wear flats are max. 1/3 of the button diameter</p> <p>Ensure all components are Sandvik manufactured. Do not "mix and match"</p>
--	--	---

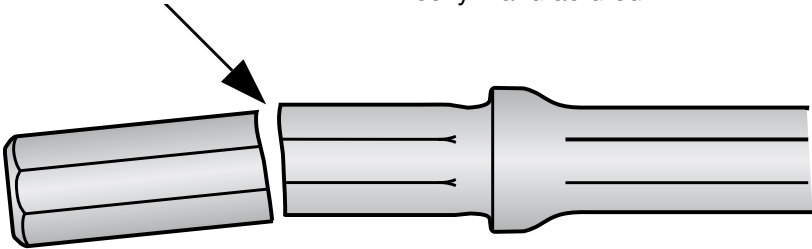
Error code Nxx

Failure mode	Probable cause	Recommended action
H:1 FAILURE IN THE SHANK END	Worn chuck bushing	Replace worn bushing
	Lack of or improper lubrication	Check that adequate volume of shank lubrication oil is reaching the shank
	Excessive feed pressure.	Reduced feed pressure
	Flushing hole in shank incorrectly manufactured	Return for analysis

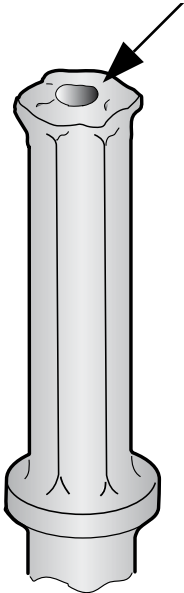
Error code C2

H:2 STRIKING FACE DEFORMED	Worn chuck bushing	Replace worn bushing
	Damaged piston	Replace piston
	High operating pressures	Adjust to rock conditions
	Hardness heat treatment not to specification	Return for analysis

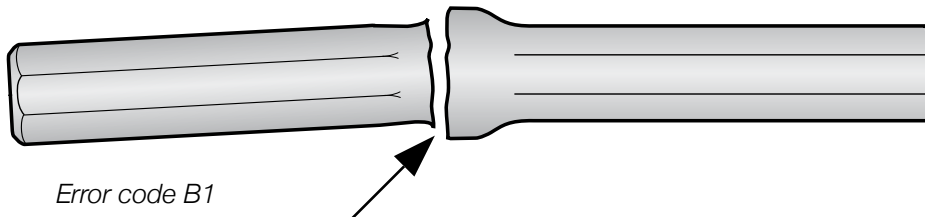
Failure mode	Probable cause	Recommended action
H:3 WEAR OR BREAKAGE AT BEGINNING OF COLLAR RADIUS	Indentation of the collar by chuck bushing. Worn chuck bushing	Replace worn bushing.
	Overheating due to poor lubrication	Ensure adequate lubrication is applied to shank
	Incorrect radius in transition between collar and shank	Return for analysis

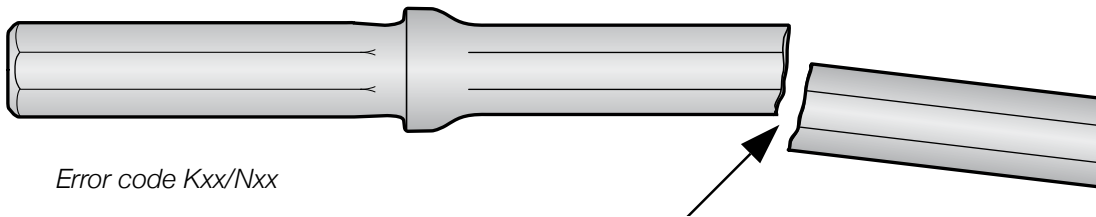
H:4 BREAKAGE IN ROD SECTION	Drilling with bent rod	Keep rod aligned
	Surface damaged	Review handling routines
	Hit at corners	Do not hit rods when stuck in hole

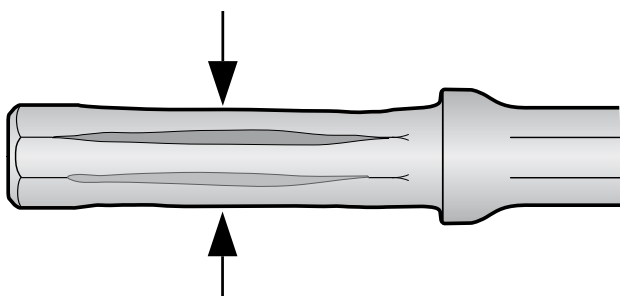
H:5 SHANK WEAR OR COKE BOTTLE WEAR	Worn chuck bushing	Replace worn bushing
---	--------------------	----------------------

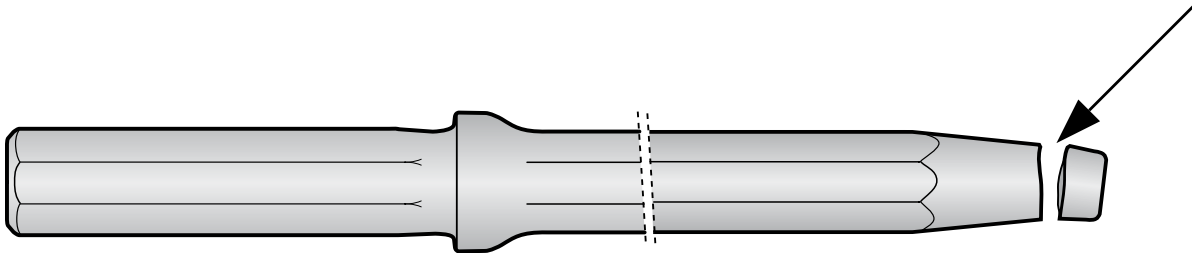
Error code B1

Failure mode	Probable cause	Recommended action
H:6 BREAKAGE ON TAPER RADIUS	Worn bit socket.	Change bit
	Using a damaged bit with a ridge or lip within the socket	Change bit or ream out ridge
	Spinning	Adjust feed force. Use Sandvik bits, do not "mix and match". Use bit with a symmetrical button design

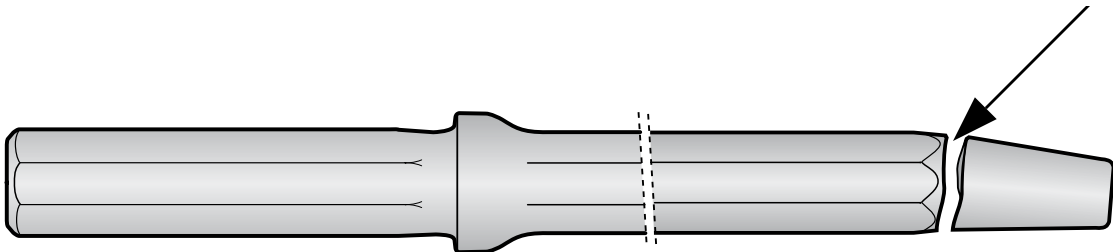
Error code Kxx

H:7 BREAKAGE CLOSE TO BIT END	Drilling through the bottom of blocks	Improve working practices
	Excessive gauge wear on bit	Change to new bit earlier. Resharpen bit when wear flats are greater than 1/3 of button diameter
	Broken from flushing hole	Return for analysis

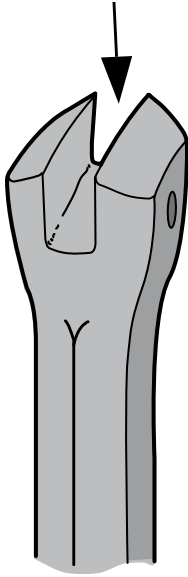
Error code L

H:8 FAILURE IN THE JOINT

Poor brazing

Return for analysis

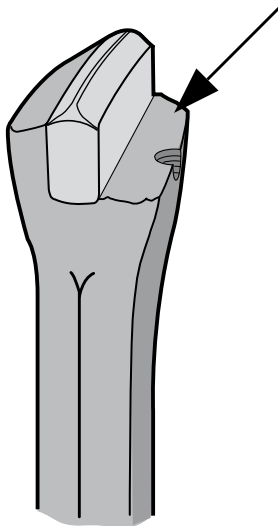
Error code F

H:9 FAILURE IN THE WING

Quality issue

Return for analysis

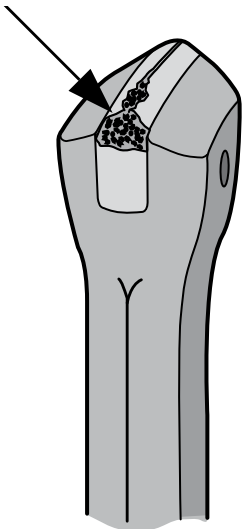
Failure mode	Probable cause	Recommended action
H:10 FAILURE IN THE CARBIDE

Improper grinding - too sharp insert corners	Follow grinding instructions
	Overheating insert when resharpening	Resharpen insert to its original shape. Follow proper grinding procedures and use correct grinding wheel
	Drilling conditions creating snakeskin	Lower rotation and reduce hammer pressure. Early regrinding even if no wear flats
	Antitaper	Employ proper grinding routines
<i>Error code S</i>

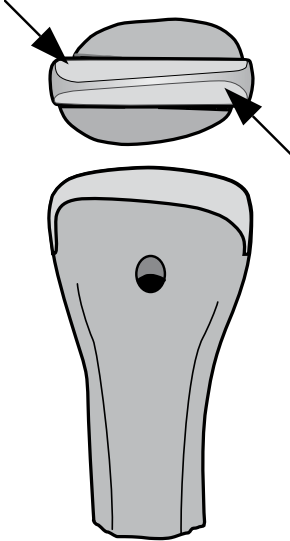
H:11 PROPELLER WEAR

Poor flushing	Increase flushing pressure
	Poor rotation	Increase rotation speed
